# Strengthening conservation and management of Lumbini, the birthplace of Lord Buddha, World Heritage Property

UNESCO project FIT/536NEP4001 funded by the Japanese Funds-in-Trust for  
the Preservation of the World Cultural Heritage

## Conservation of archaeological remains Final report

Costantino Meucci  
2013

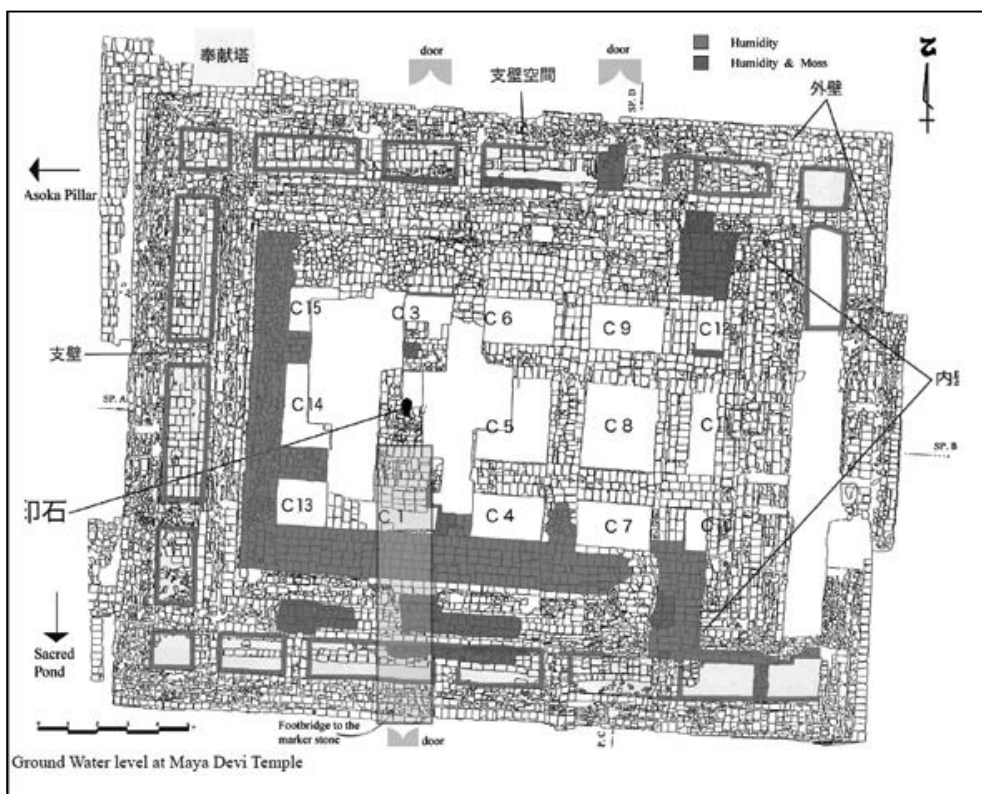
Figure 103. Distribution of the degradation patterns

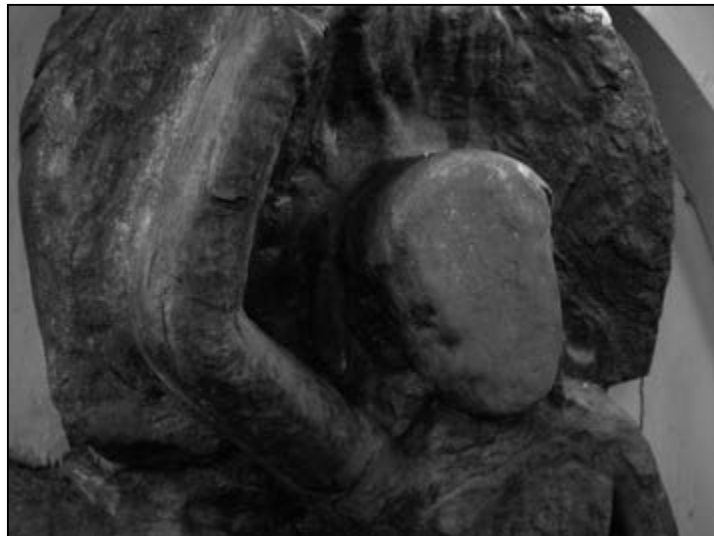
**Figure 115. The hard resin caused scaling and stone powdering**

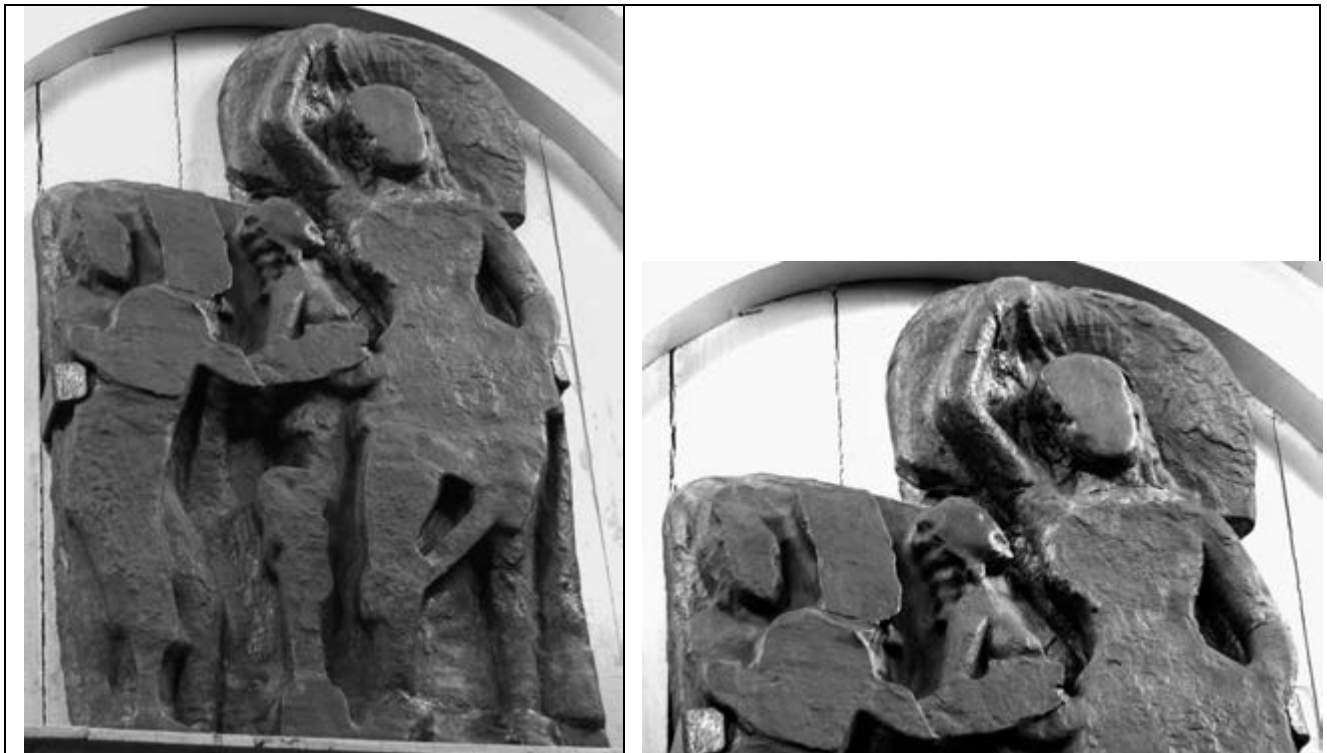
**Figure 117. Nativity Sculpture as appears after the Maya Festival**

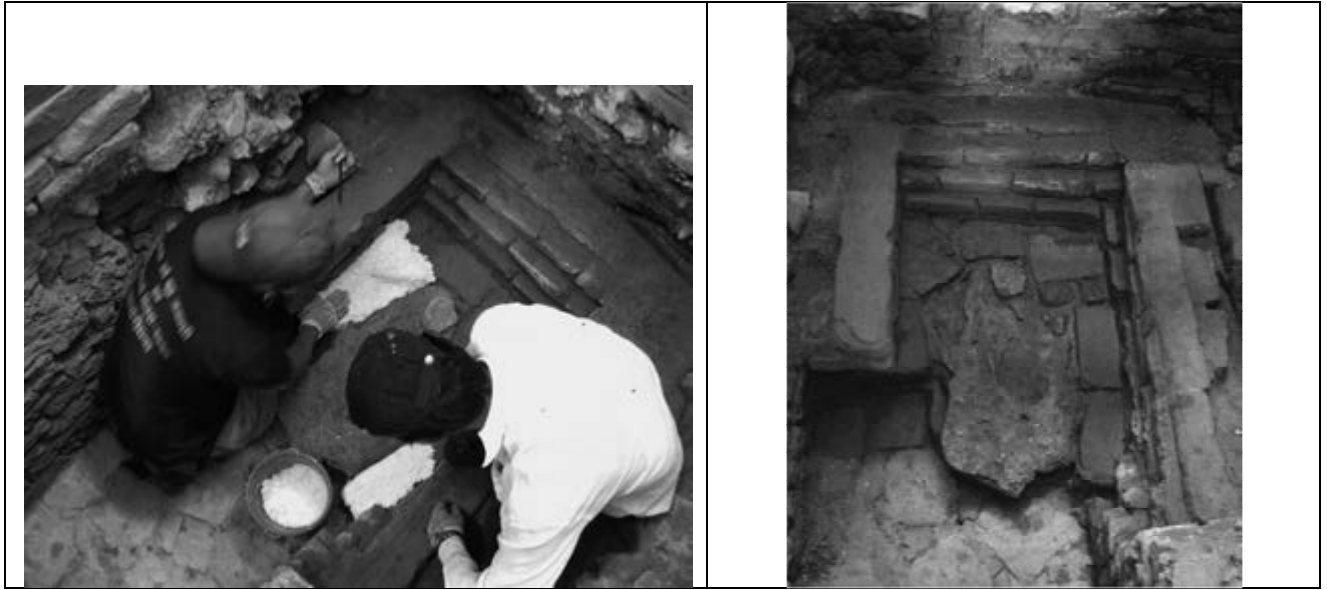
**Figure 121. The Marker Stone as appeared after the Maya Festival.**

Figure 122. Marker Stone: left) during, and, right) at the end of the final restoration

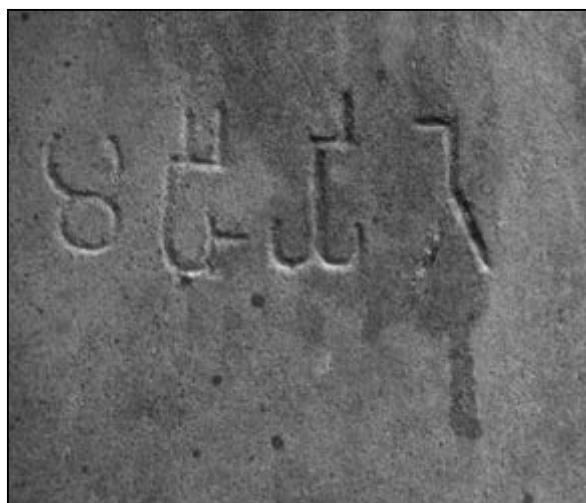
**Figure 133. The corroded area on West side after the treatment with ESTEL 1000.**

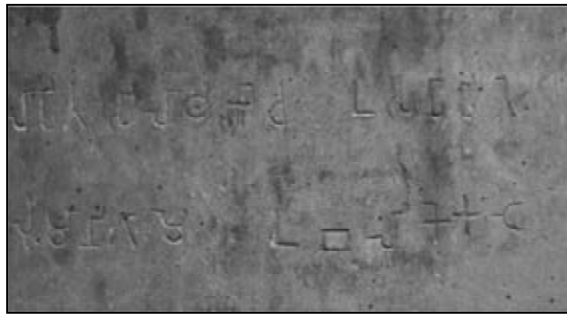
**Figure 134. The letters before cleaning show several damages due to the offerings.**

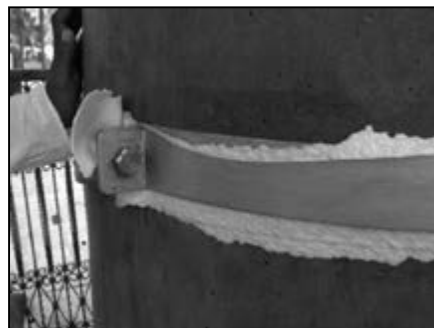
**Figure 137. Corrosion products affect the stone under the belt.**

**Figure 138. Applying the silicon rubber protects the stone from the iron corrosion products.**

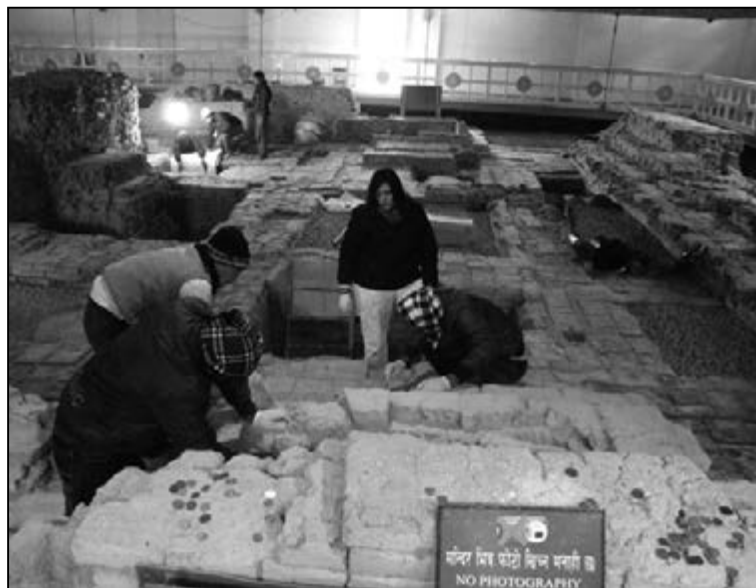
**Figure 156. Degradation of the bricks in Trench C7**

**Figure 157. Mechanical cleaning of the south Wall**
