Strengthening conservation and management of Lumbini, the birthplace of Lord Buddha, World Heritage Property

UNESCO project FIT/536NEP4001 funded by the Japanese Funds-in-Trust for
the Preservation of the World Cultural Heritage

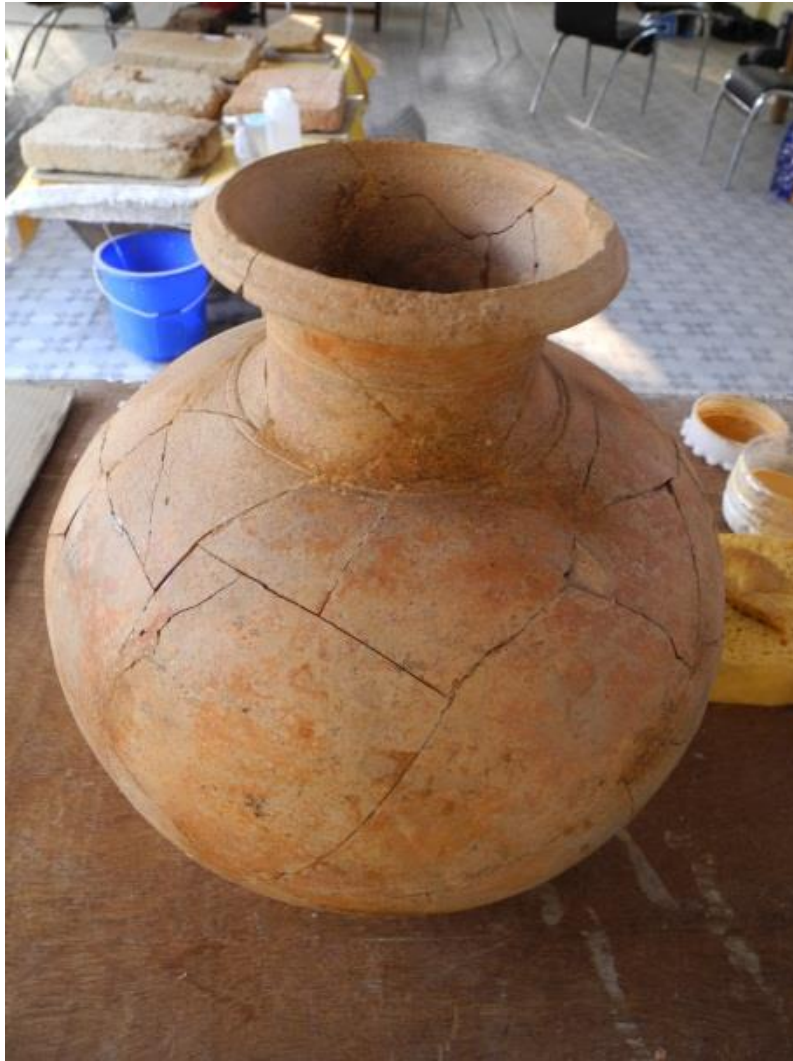
Figure 9.1. Reconstructed Red Ware vessel found in Monastery Trench 1 in 2012. (SF#1538)

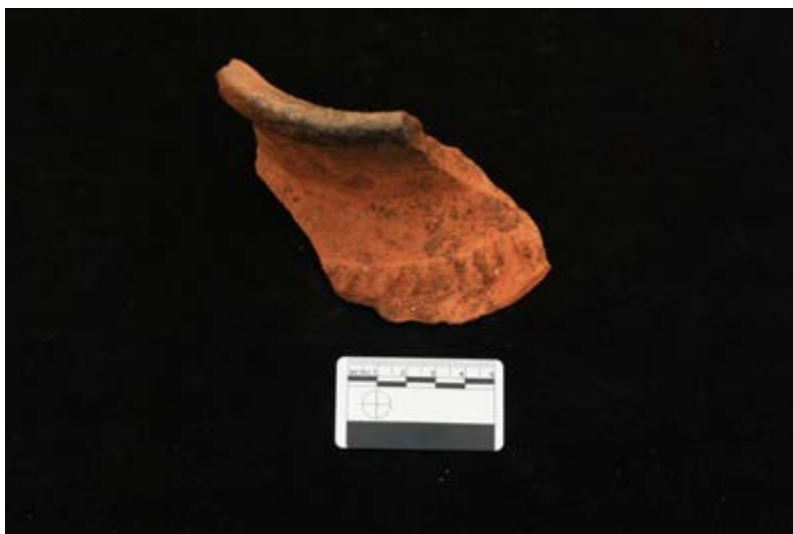
Figure 9.2. Cord Impressed Ware with highly visible cord impressions on the rim of the sherd. (SF#8466)
