# Strengthening conservation and management of Lumbini, the birthplace of Lord Buddha, World Heritage Property

UNESCO project FIT/536NEP4001 funded by the Japanese Funds-in-Trust for  
the Preservation of the World Cultural Heritage

## Conservation of archaeological remains Final report

Costantino Meucci  
2013

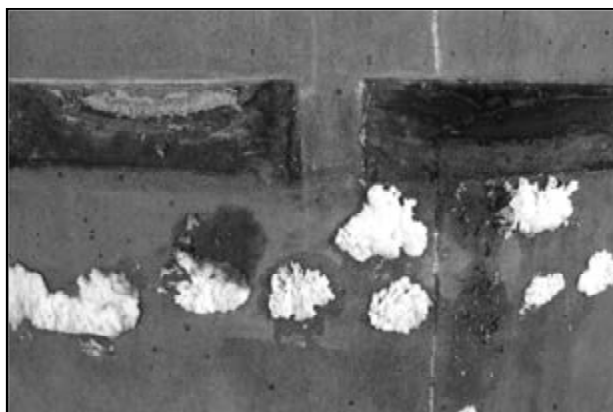
**Figure 10. The surface of Pillar after the removal of the lower belt**

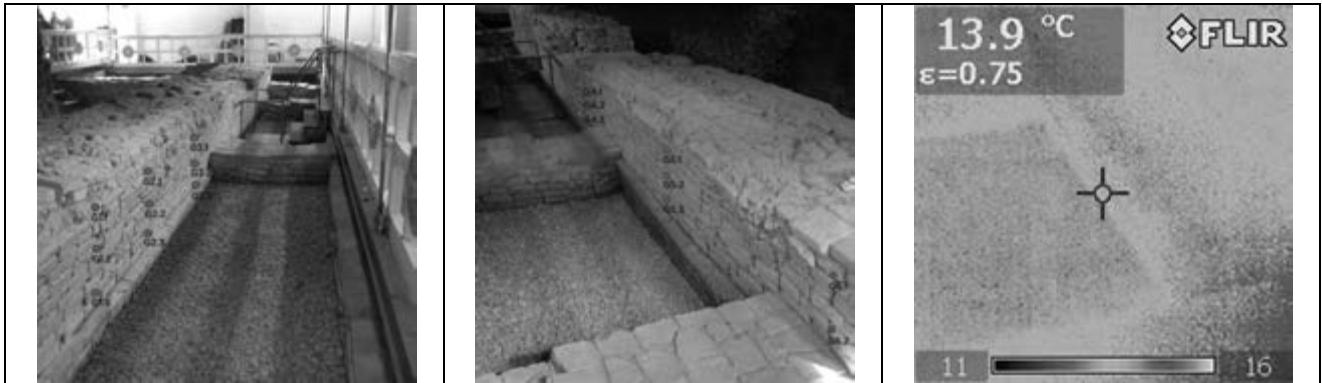
Along the West Wall six different locations were checked (figure 72) in order to individuate eventual anomalies in the masonry, owing to the high values of water content detected in the inside surface of the same wall. As figure 73 reveals, the wall is water saturated till the top level confirming what was observed by IR inspection. The FLIR image of figure 72 shows that the bottom of the wall is colder than the top both because of the capillary and this is attributed to the air circulation inside the Mayadevi Temple.

**Figure 72. West Wall: Measuring point locations and water distribution of G4-G5-G6 locations.**

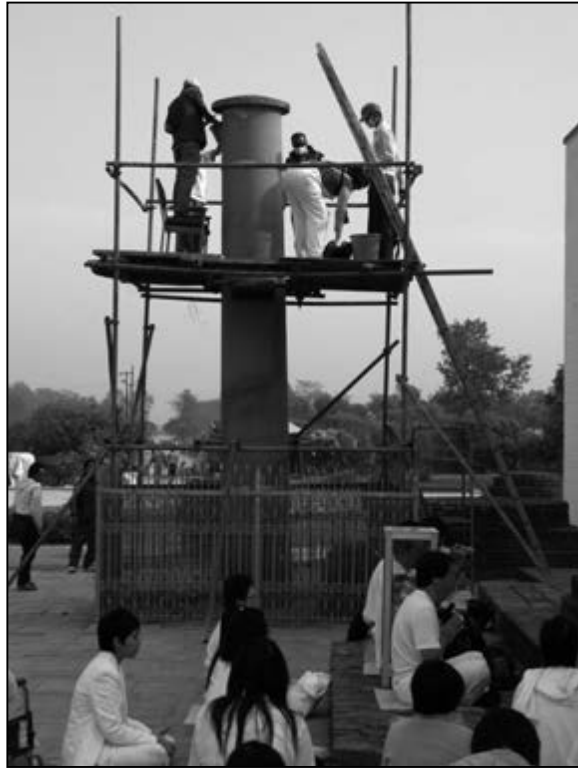
The practical restoration activity started on April 6th 2011 on the Ashoka Pillar, where scaffolding was built to reach the top of the Pillar. Initially, the scaffolding was not suitable to carry out any restoration work because of the lack of walking planks and the shaking that occurred when people got on them. However, it was made secure to ensure safety during the restoration work (figure 113). On April 7th, the protective box of the Marker Stone was removed in order to verify the results of the biocide treatment and to continue the restoration. Nevertheless, the restoration activities suffered a consistent delay because of the lack of

**Figure 113. Scaffolding around the Asokan Pillar during the restoration work**

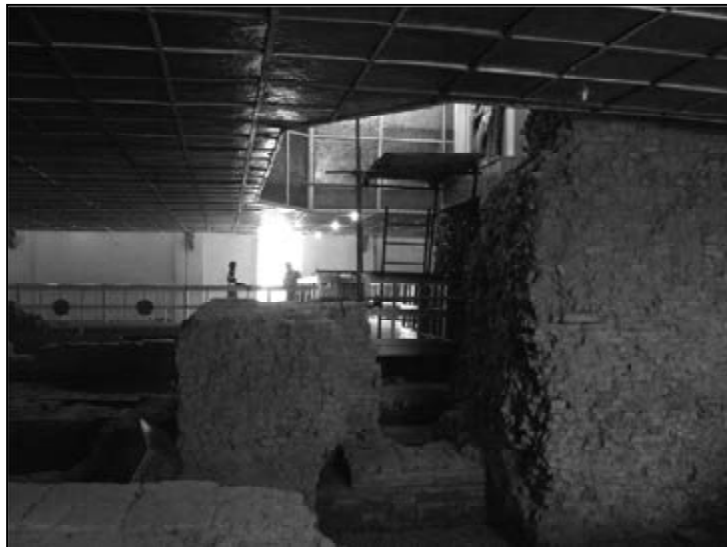
On April 11th a service scaffolding was built to enable the conservation team to reach the Nativity Sculpture; as figure 114 shows, the safety is relative, but the restoration activity started immediately.

**Figure 114. The scaffolding built on the Nativity Sculpture.**

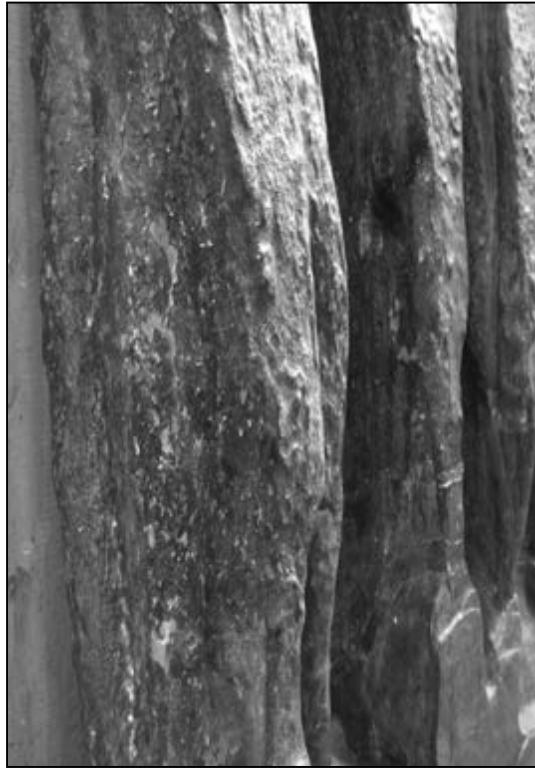
Furthermore, all areas where this degradation pattern is present show (figure 115) that the hard scales are detached from the substratum that is locally powdered. The cleaning test performed using Ammonium Carbonate 10 per cent w/w solution did not work properly because of the presence on the surface of some remains of PVA and of the red resin layers. Using a 2A solution applied by toothbrush, new tests were carried out, aiming to definitively remove the organic layers. Figure 116 shows how the original colour of the stone has changed owing to the colours applied on the surface, while the sandstone was originally pale yellow with both red iron oxide and grey chlorites veins. Cleaning was completed on April 16th except for the lowering of the epoxy plaster applied to glue the separated part of the statue.

**Figure 115. The hard resin caused scaling and stone powdering**

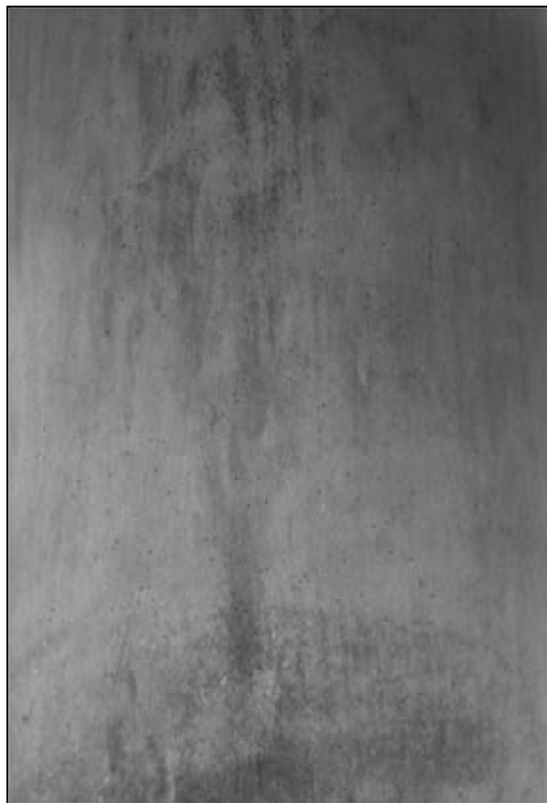
**Figure 133. The corroded area on West side after the treatment with ESTEL 1000.**

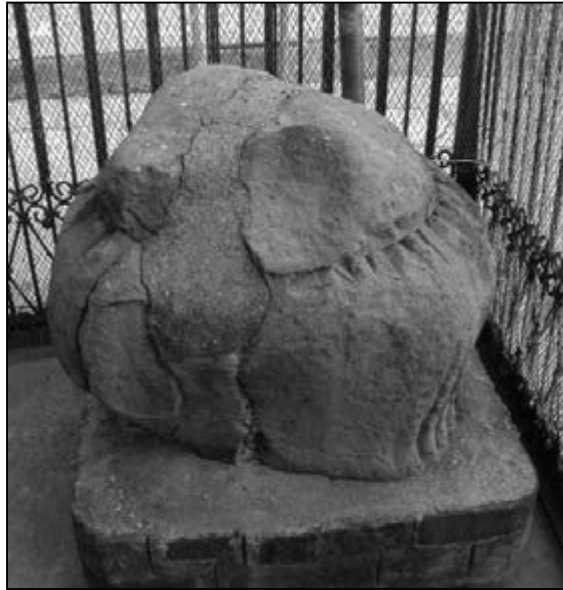
**Figure 140. The capital before restoration**

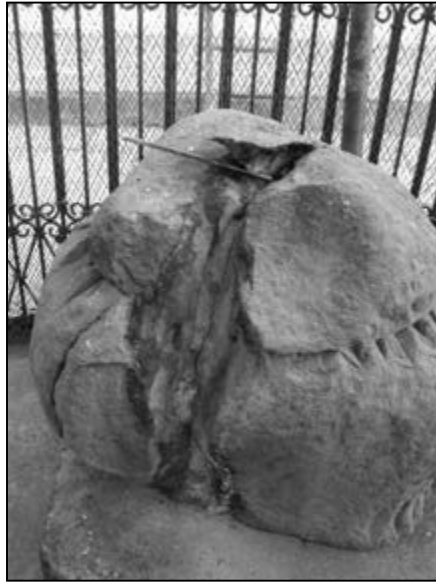
**Figure 141. The two elements of the capital are connected with cement concrete**

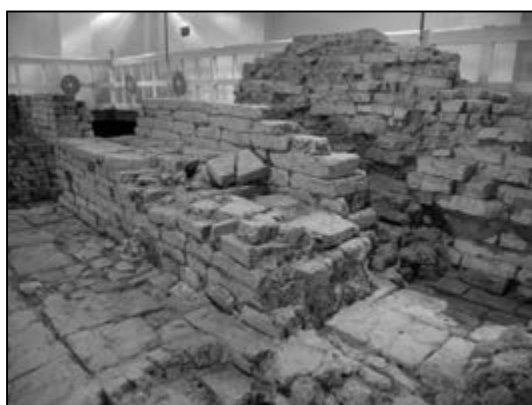
**Figure 154. The wall before the restoration**

The mission of the year 2013 aimed to complete the monitoring of the Mayadevi Temple and to identify the best solution for the restoration of the masonry. Thus, the restoration took into account the limited section corresponding to the northern side of the South wall (figure 154); the base of the same wall till the walkway; and the walls of the Trench C7.

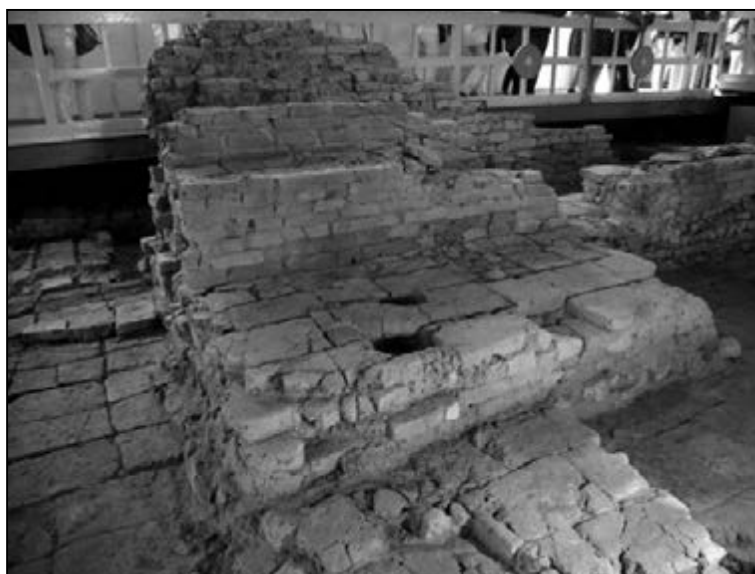
Applying this methodology, the base of the South Wall reaching the central walkway was cleaned in a very short time and this has produced good results. (figure 159). At the end of the cleaning process, all fissures and cracks produced by degradation into the brick surface became evident (figure 160), while emptying two holes individuated in the plan of the inner platform revealed the base of two different poles, which were probably used to support a tent. With the aim to increase resistance to the degradation and the collapse of the masonry, all fissures were filled with a lime plaster (figure 161) made by mixing sand and brick powder with hydrated lime in the ratio of 1:1:1. The same plaster was also used to repair and join some broken bricks (figure 162) and to fill the mortar between the bricks as well. After two days of natural drying, all surfaces were sprayed with a protective solution obtained by mixing four parts of the (40+60) per cent v/v Silo 111/Estel 1000 solution, with six parts of the (40+60) per cent v/v White Spirit/Isopropyl alcohol solution (figure 163). Due to the chemical reactions involved, this peculiar mixture will obtain the double result of strengthening the surface of the bricks, avoiding the powder within, and waterproofing the surfaces (figure 164), thereby reducing the absorbance of water from the environment in the cold season. However, in case of strong capillary from the soil, water may evaporate freely as well.

**Figure 160. The South wall after the cleaning**

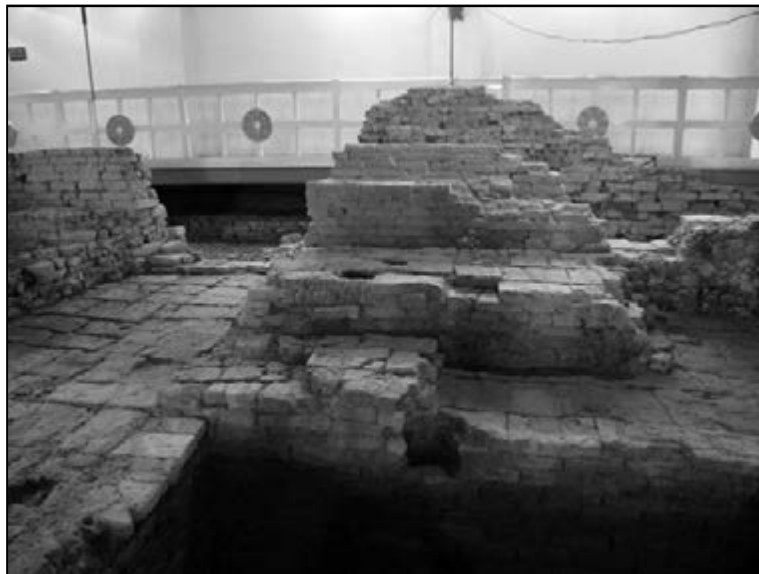
**Figure 164. The South wall at the end of the restoration**
