# Strengthening conservation and management of Lumbini, the birthplace of Lord Buddha, World Heritage Property

UNESCO project FIT/536NEP4001 funded by the Japanese Funds-in-Trust for  
the Preservation of the World Cultural Heritage

## Conservation of archaeological remains Final report

Costantino Meucci  
2013

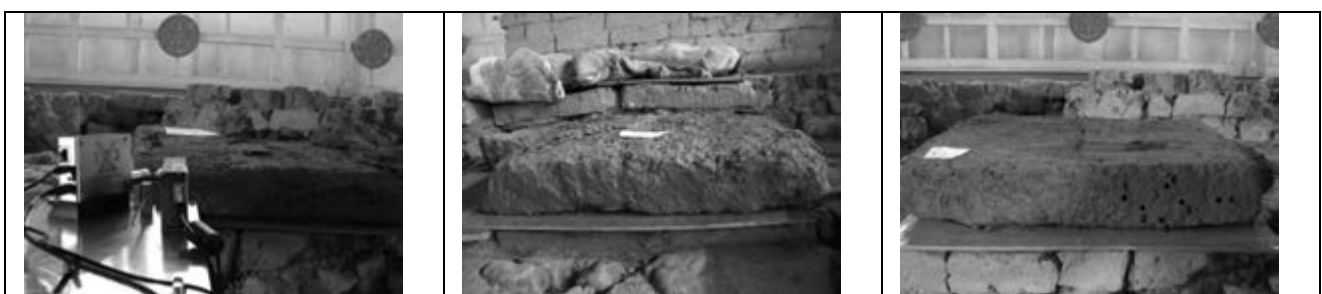
The tall bricks recovered from the platform of the pre-Ashoka phase of the Temple (Coningham and Acharya, 2011) found in Trench C5, were subjected to XRF analysis (figure 20) owing to their peculiar size and apparent texture; indeed, they appear very porous and fragile because of the great abundance of straw mixed with the clay and the apparent low-firing temperature. Before performing the analysis, small areas of the brick surfaces were mechanically cleaned by scalpel to prevent the mud layer adhering to the surface which alters the compositional values.

**Figure 20. Performing XRF analyses on MD279 and MD280 bricks**

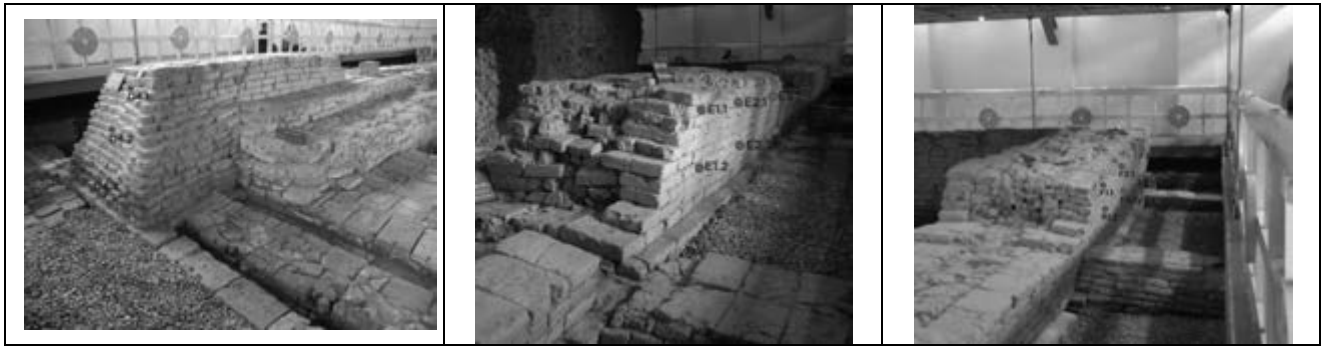
Three locations corresponding to different conservation situations were investigated: D4 is the rebuilt extremity of the restored East Wall, location E is the central part of the wall in front of the entrance door, while location F is at the North-West corner of the perimetral wall (figure 69). Comparing the recorded values of water content (table 22) indicated that each location behaves in a different way owing to their peculiar shape. Sector D4 shows the minimum value (figure 70) in the intermediate location, which corresponds to the inner oldest wall reach of water, as measurements on North Wall confirmed. In location E, the high level of the pebble refilling the trench indices that water rises to the top wetting the whole masonry. Indeed, looking at the IR image (figure 71) confirms that, regarding the entrance door, only the temperature of the upper brick row has an influence, thereby increasing the effects of the capillary. The last location F has some differences due to the peculiar geometry of the wall: indeed, the North-West corner shows that the water content decreases with the height being minimum at the top, which is directly exposed to sunlight, while the bottom is water saturated.

Figure 69. North Wall: water content detecting locations..

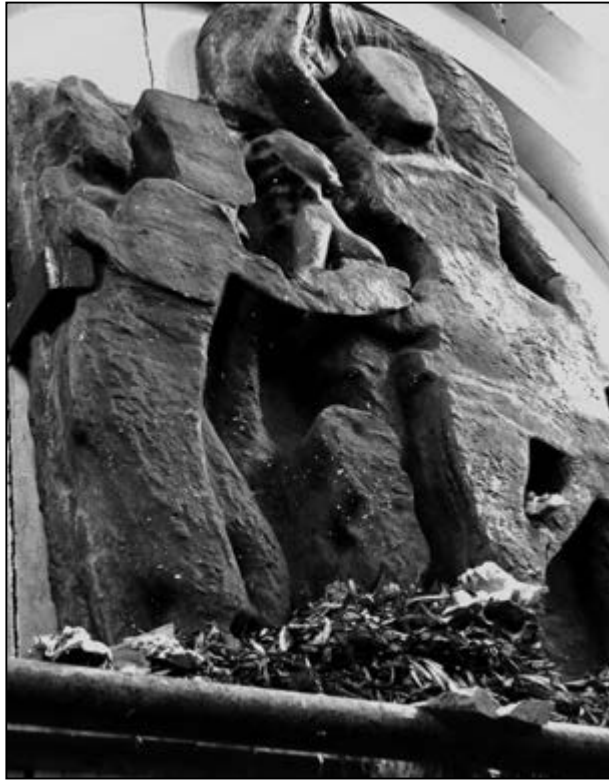
All activities were stopped on 18 April for the Maya Festival and part of the scaffolding was dismantled and the temple was opened to the visitors. The number of pilgrims was very high in that period and when on 21 April the festival completed, the appearance of the sculpture was as shown in figure 117. The lower part of the relief was painted with the purple colour, while sugars and milk were thrown up onto the Mayadevi face causing white spots to adhere to the surface. Thus, the sculpture needed new cleaning that was done through using 2A solution (applied by toothbrush) and a scalpel to remove the adhering sugars. Applying ESTEL 1100 (CTS – Italy), which is a mixture of ethyl silicate and alkoxy-silane, performed the final protective treatment. The choice of this chemical was justified by the necessity to

**Figure 117. Nativity Sculpture as appears after the Maya Festival**

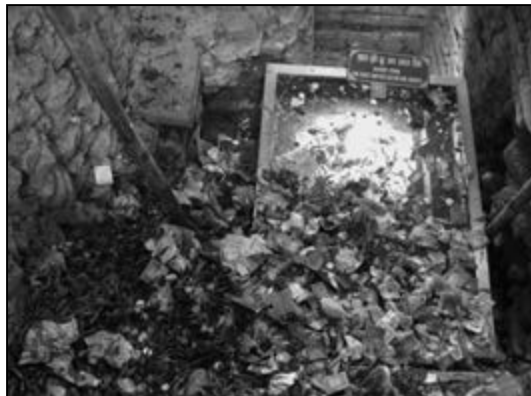
On April 18th, the start of the Maya Festival enforced the temporary termination of the restoration of the Nativity Sculpture and the temple was opened to the visitors. Part of the scaffolding was then removed and the Marker Stone was temporarily protected with a transparent box to enable the pilgrims to view it. Figure 121 shows the situation after three days of the Maya Festival. Several kind of offerings cover part of the box and contaminate the surroundings, increasing the organic pollution and the risk that biological attack develops quickly.

**Figure 121. The Marker Stone as appeared after the Maya Festival.**

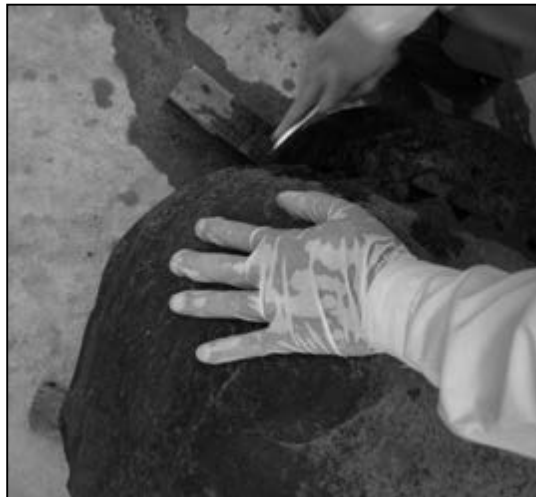
The external surface of the Capital showed several layers of organic matter strongly adhering to the stone and sometimes deeply penetrating its porosity. The cleaning was done by paper pulp compresses saturated with the mixture 1:1 of Ammonium carbonate and EDTA 10 per cent w/w solutions. The minimum contact time was 12 hours, but after that time, sponge and water removed most of the black remains. However, many black spots penetrate the external porosity and the superficial lack of material, changing the appearance of the stone. Applying the 1:1 v/v mixture of Hydrogen peroxide and Ammonia liquor (HP/AL mixture) performed the cleaning. This mixture, in fact, reacts with oils and fats, originating water-soluble compounds that may be simply removed with a tooth-brush and wet sponge (figure 142).

**Figure 142. Performing the cleaning with HP/AL mixture.**
